January 28, 2015

**Re: Updated Limited Geotechnical Site Evaluation**  
Old Firehouse – 510 NW 3rd Avenue  
Portland, Oregon  
15916-06

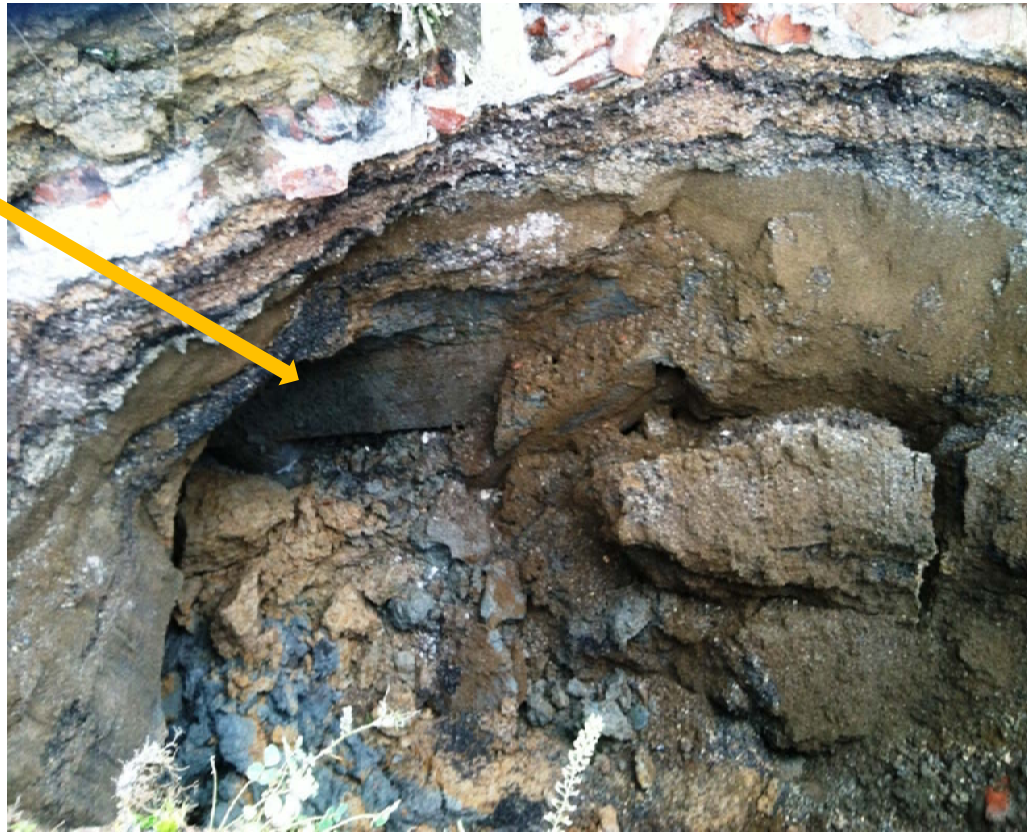
Buried  
Beam

Severe caving was observed in test pits TP-1 and TP-2 on the eastern side of the building after a depth of 11 feet bgs. These test pits were terminated at this depth due to caving. Caving in these test pits revealed pile-supported beams set at an angle (approximately 30 degrees) to the existing building foundation approximately 7 to 8 feet below the existing ground surface. Test pit TP-3 encountered a

Buried Pile Supported Beam in TP-1

7.5				Wood beam observed in side of test pit at approximately 7.0 feet.			
10.0	GRAB S-7						H ●

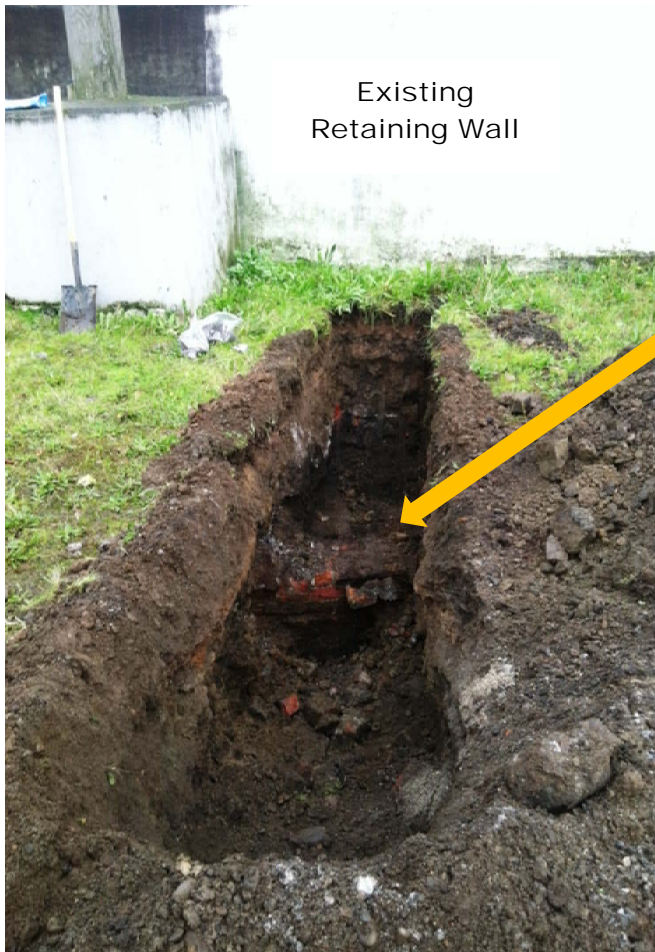
buried brick wall approximately 3 feet bgs, along the north side of the building. We anticipate that these structures were portions of basements or foundations for previous structures at the site, possibly those noted in our historic research. Photographs of the wall and the beam uncovered in test pit TP-1 are included on Figure 3.

Buried Wall Encountered in TP-3

4.5 - 5.0	GRAB S-2		[Hatched pattern]	Brick wall encountered between 3-5 feet (see Figure 3).				
5.0 - 7.5		ML	[Dotted pattern]	(ML) (Soft to very soft), moist, brown with orange and brown mottled, SILT with sand, low plasticity. (Fill)
