# Building Inspection Report

510 NW Third Avenue  
Portland, OR. 97209

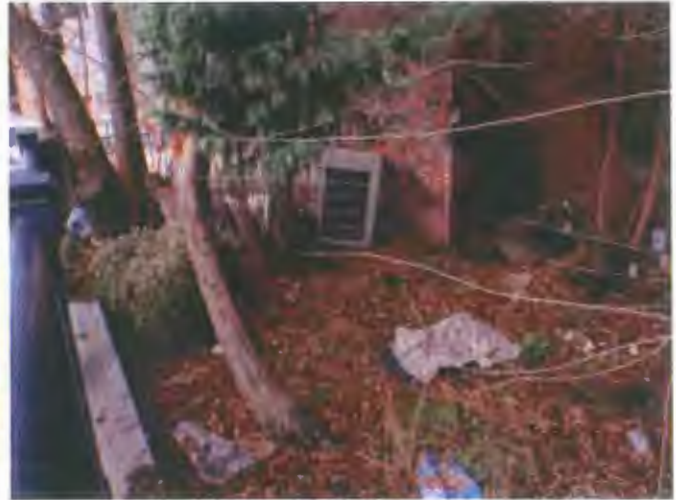
West end of the south side yard and additional mess and damage needing clean-up.

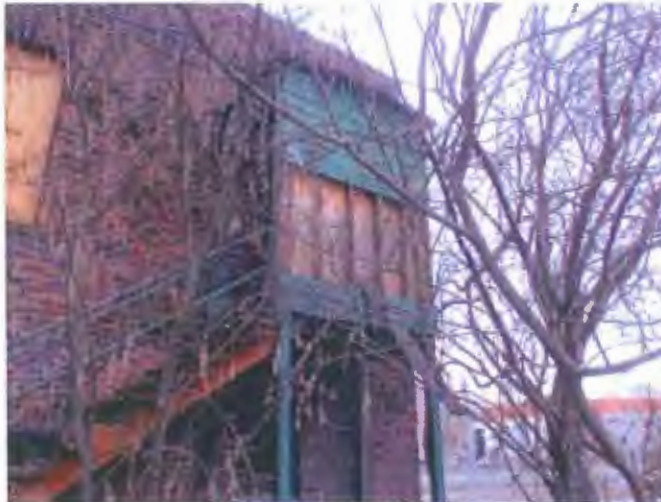
The trees need to be pruned back off the building.

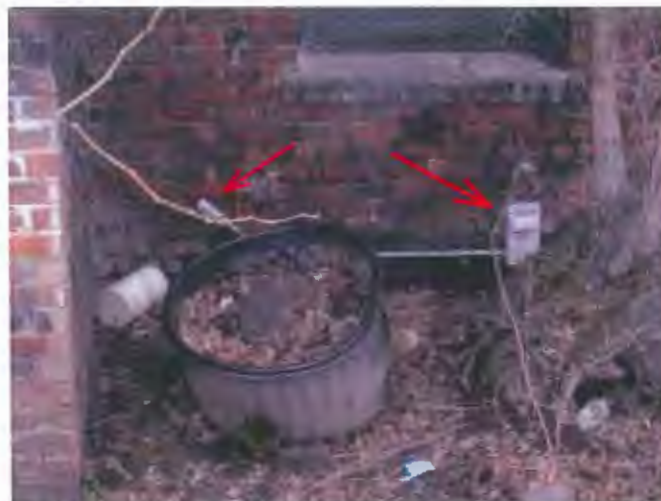
The south side air conditioning wiring has been damaged.

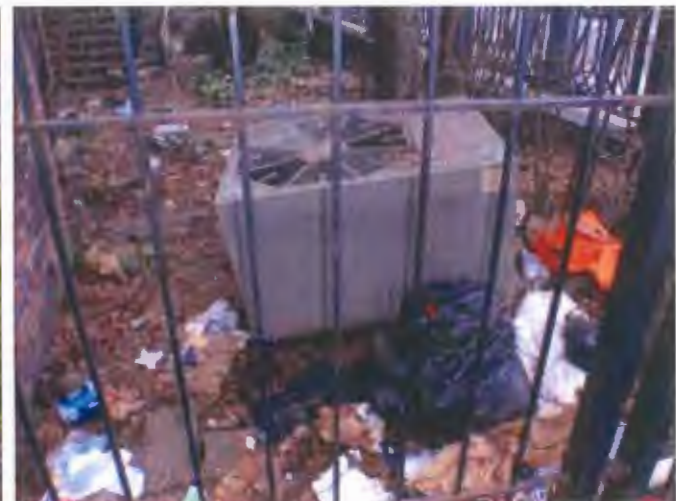
The south side AC compressor unit has been ripped off the building.

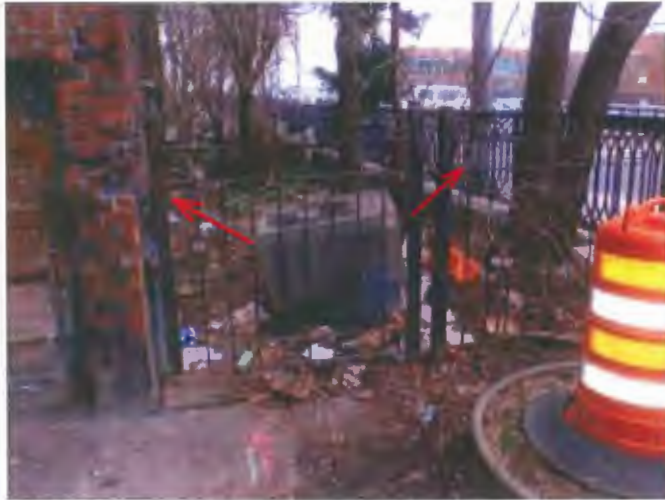
The rusting south side steel fencing needs repair and painting.

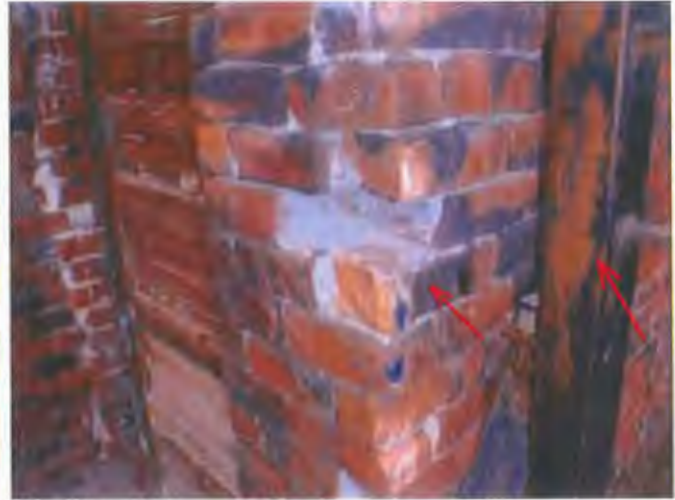
See the SW corner brick damage and rusting steel fence.

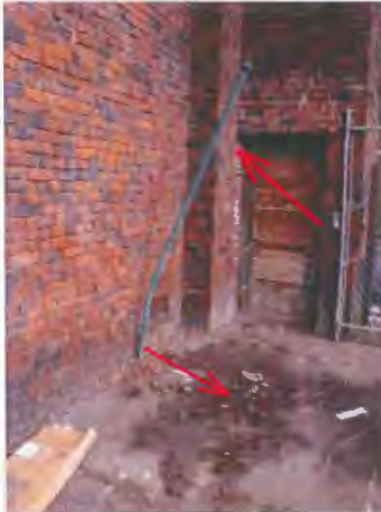
The SW corner of the property has an underground oil tank with bent vent pipes.

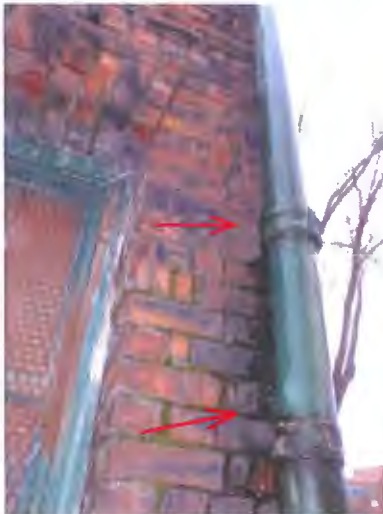
The SW cast iron roof drain is clogged and leaking down the building corner causing damage.

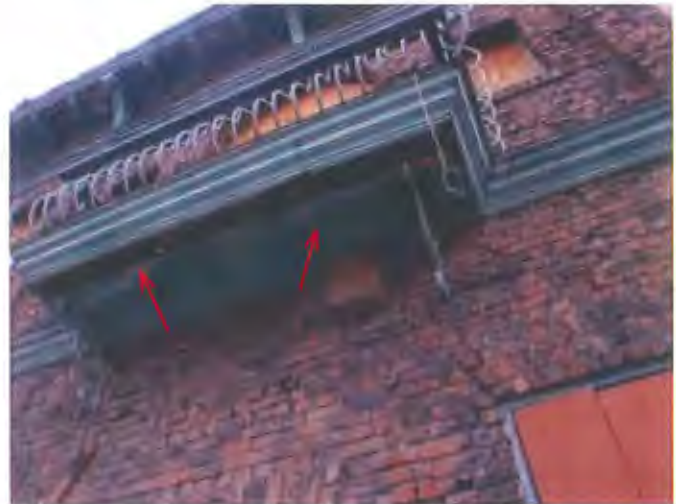
Water induced wood rot in the front balcony.

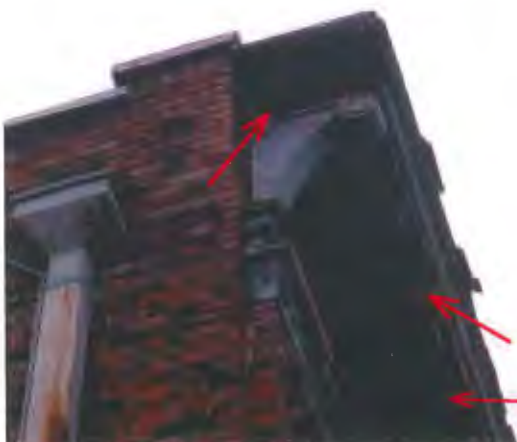
The front corbelled soffit has extensive wood rot damage.

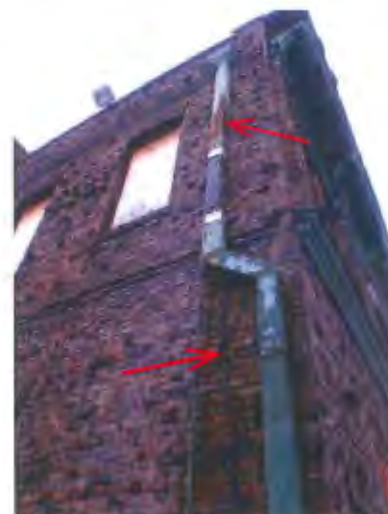
The metal NW building corner roof drain is also clogged and leaking.

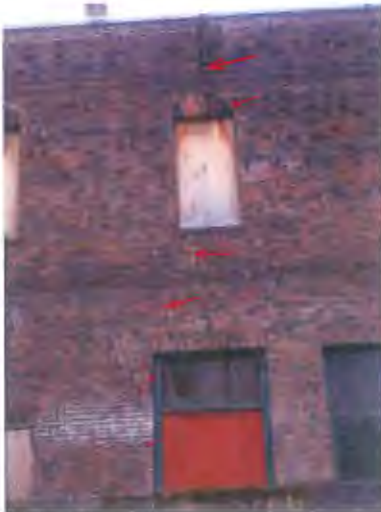
Serious north brick wall settlement crack. The south wall is cracked too.

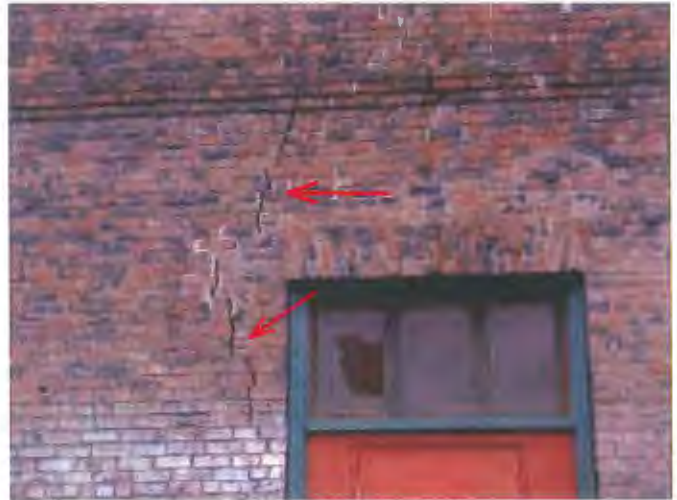
The crack runs the full height of the wall and indicates East end building settlement

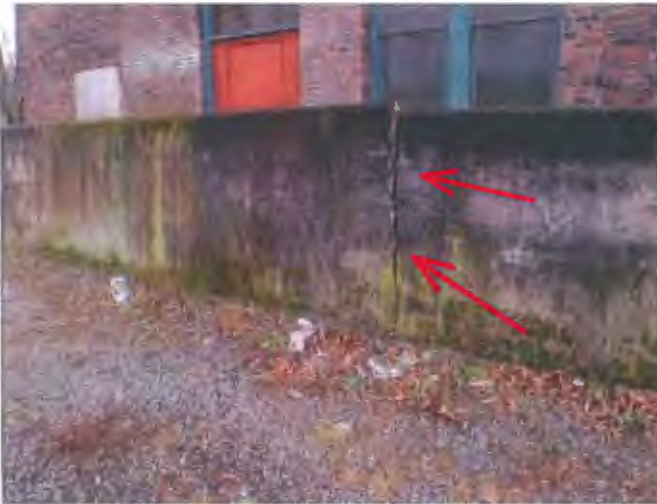
The newer north side concrete wall has cracked also. This may indicate more recent settlement.

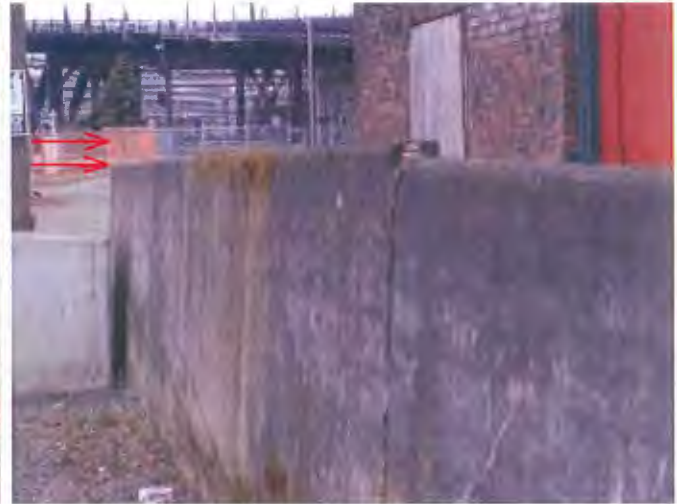
See the considerable site settlement at the northeast corner of the building and concrete wall.

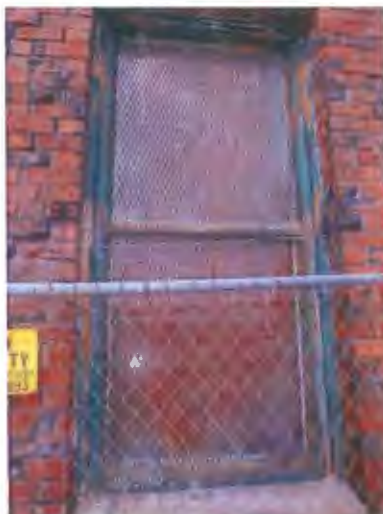
Some of old wood windows are still intact but need extensive restoration or full replacement.

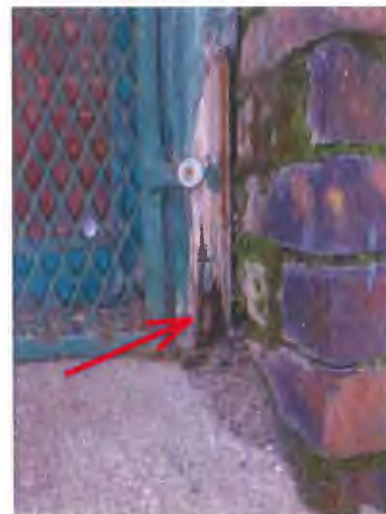
See the wood rot in the window trims and window jambs.

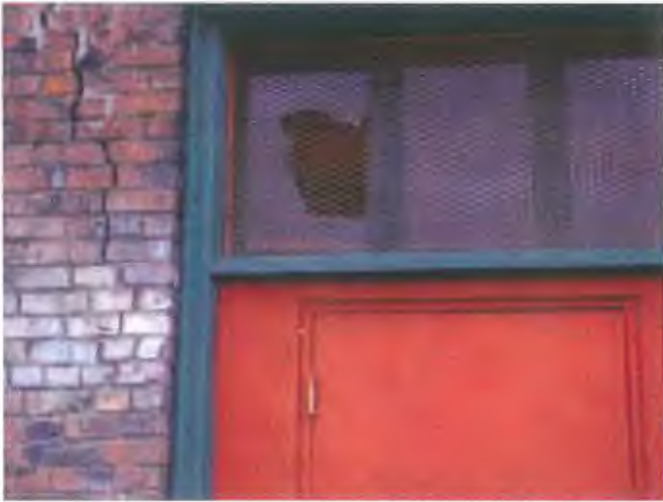
Lots of broken and boarded up windows.

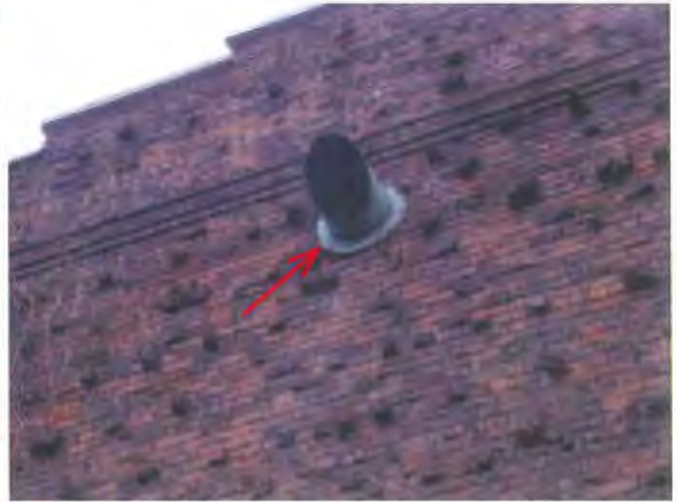
The east side vent was for the mess hall and possibly smoking area on the top floor.

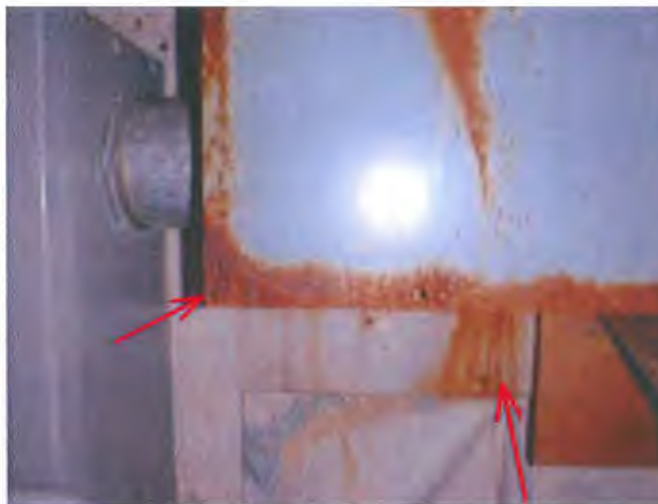
Rusted electrical service sub-panel wiring race-way.

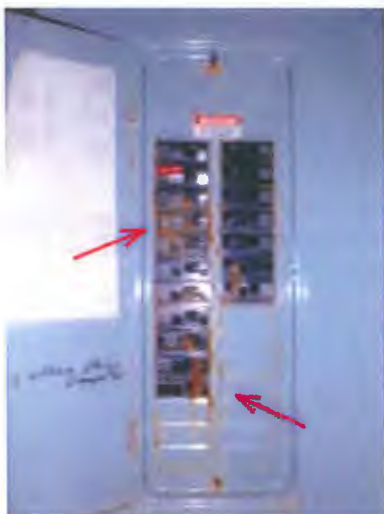
See rusting house panel. Panels were unsafe to open without service shut off.

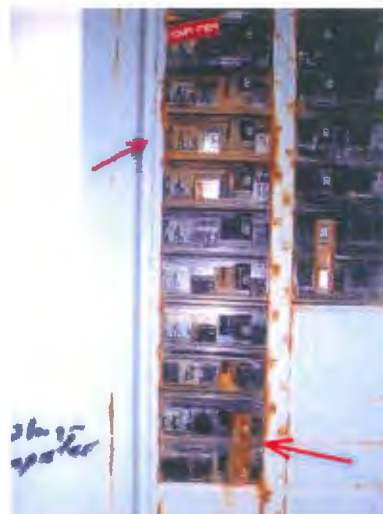
See heavily rusted circuit breakers and panel needing careful attention.

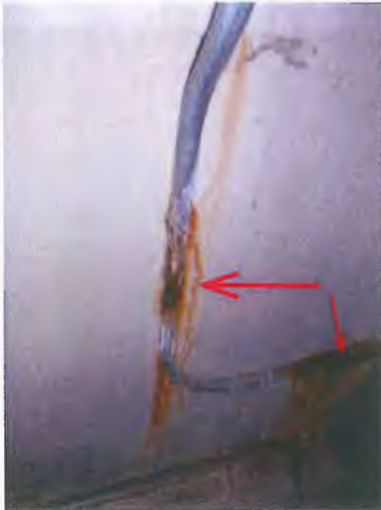
See seriously corroded electrical conduit too.

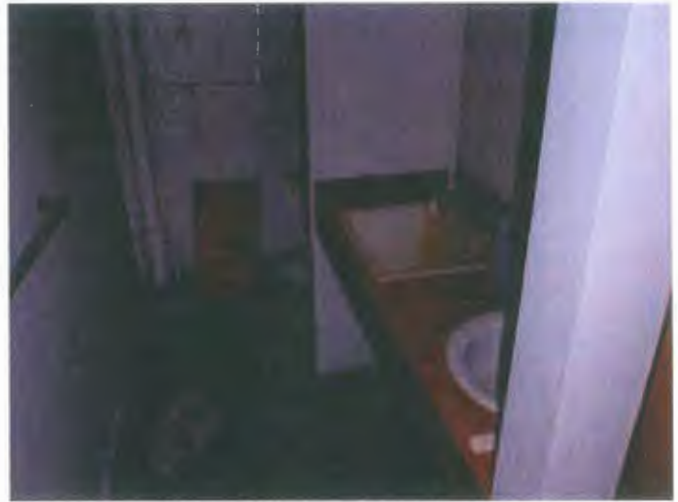
One of the main floor baths.

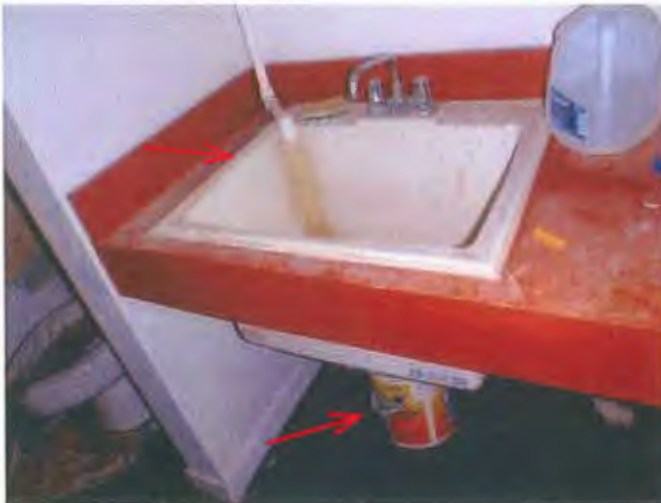
See stained sinks and buckets at the drain trap.

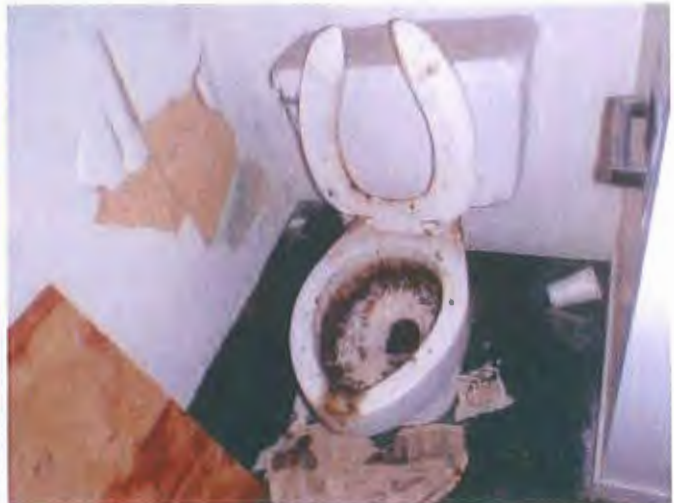
The plumbing has been abused and will need full flushing of all drains and extensive restoration.

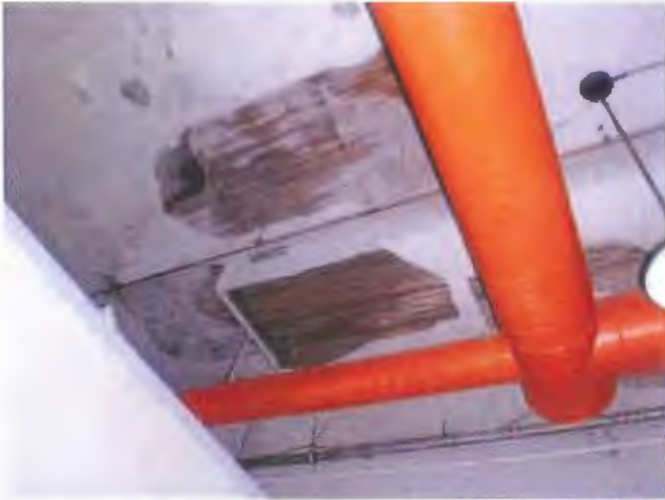
See roof leakage damage and mold in the first floor hall ceiling.

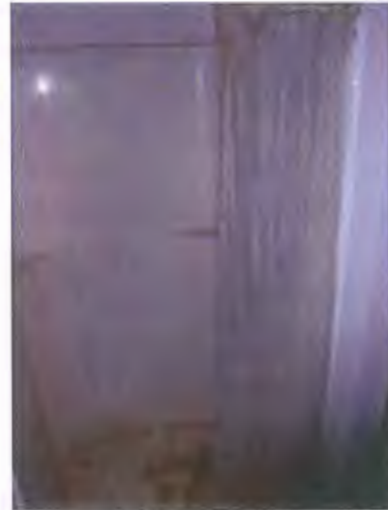
The second main floor bath has a fiberglass shower.

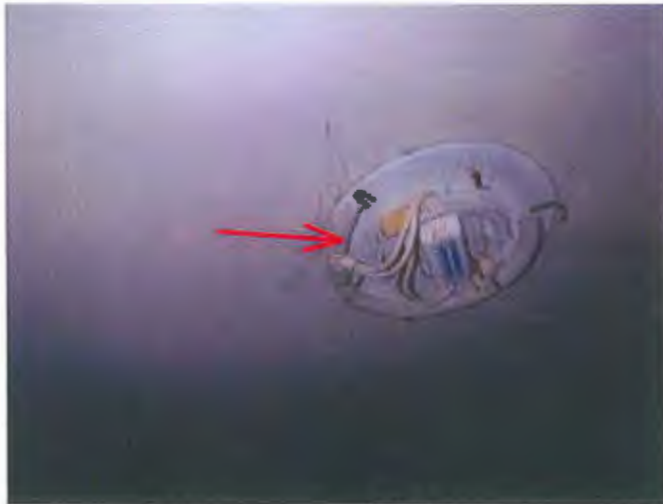
Lots of damaged light fixtures.

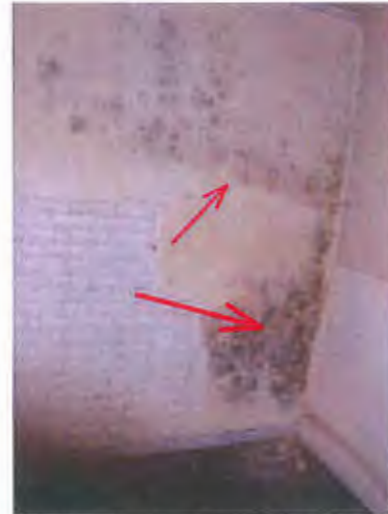
See mold developing around perimeter and especially at south side of the building.

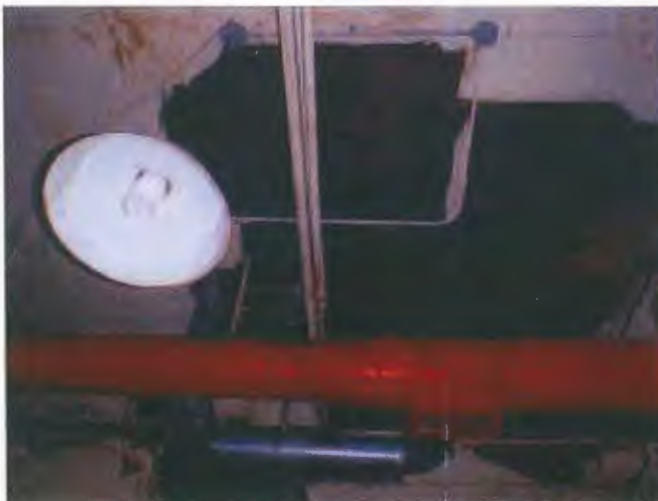
The roof leakage is destroying the building along the south side.

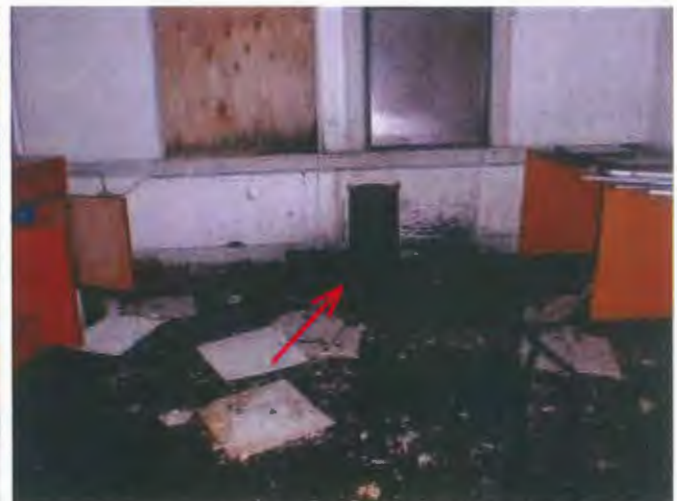
View of a wet moldy main floor south side office space.

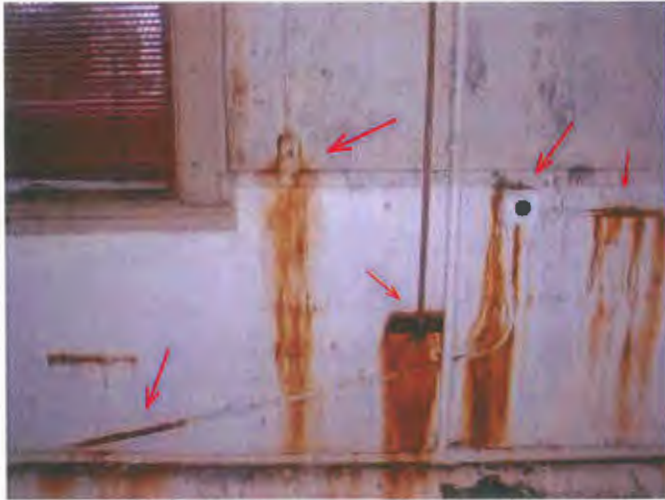
See water intrusion into the electrical boxes and raceways. This wiring needs replacement.

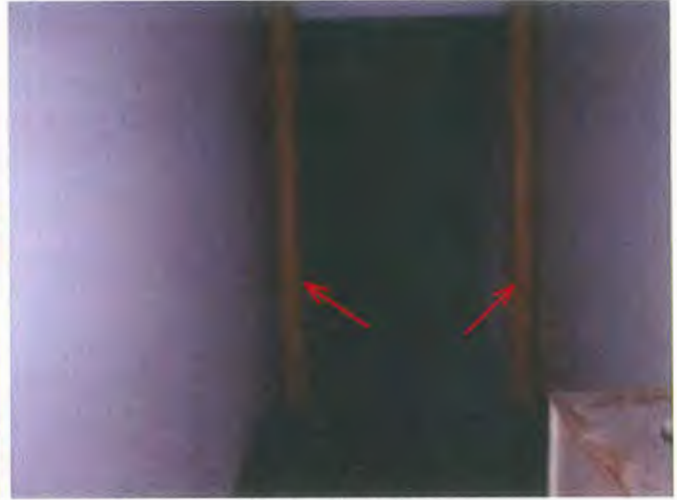
The roof structure is wood timber trusses with steel columns and beams for second floor support.

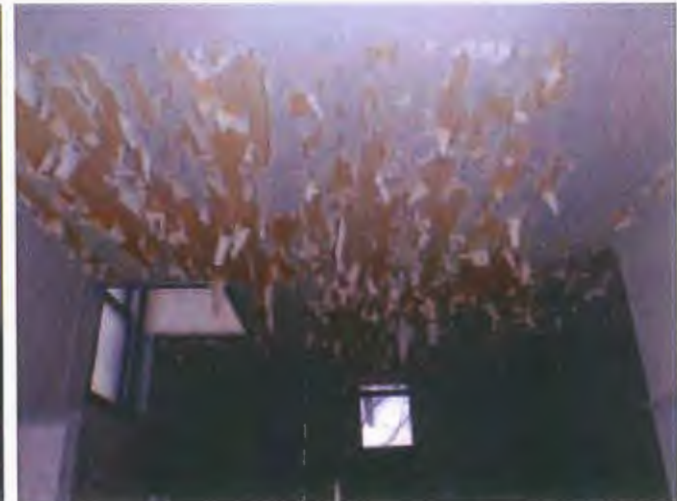
See damaged east main floor room's ceiling. A lead paint nightmare?

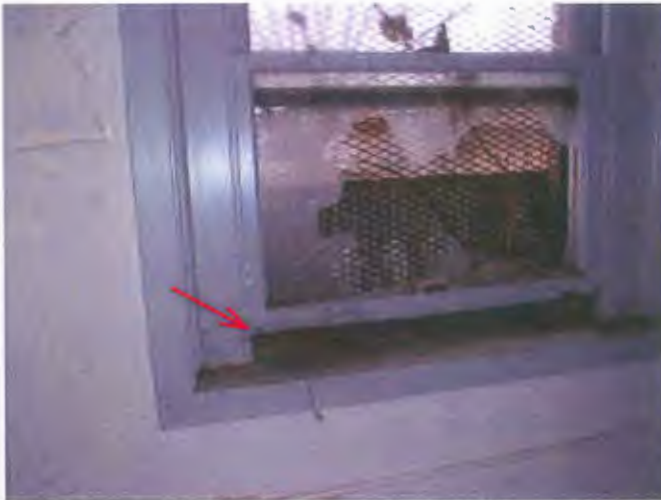
Need open broken windows boarded up to keep rodents out.

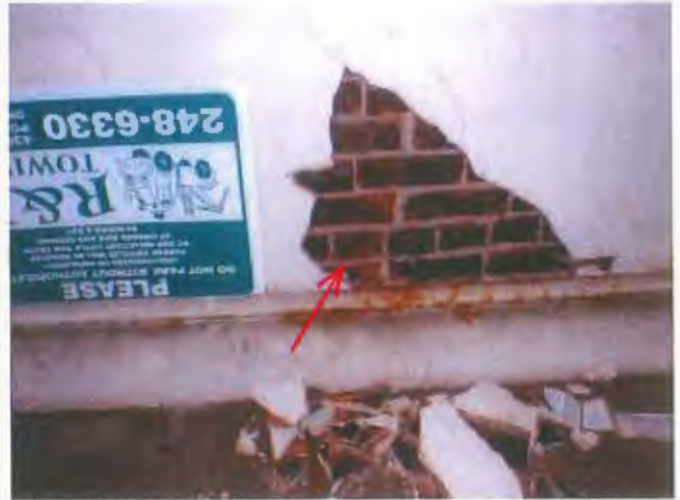
The building's exterior walls appear to be full brick and will need serious seismic upgrades.

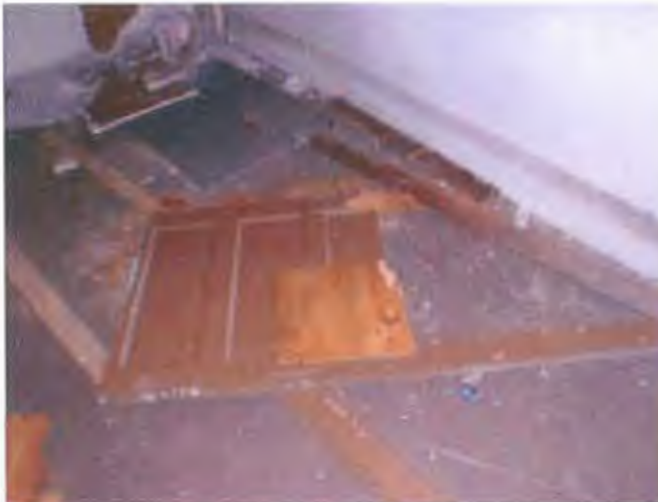
Many interior doors are now just broken scraps.

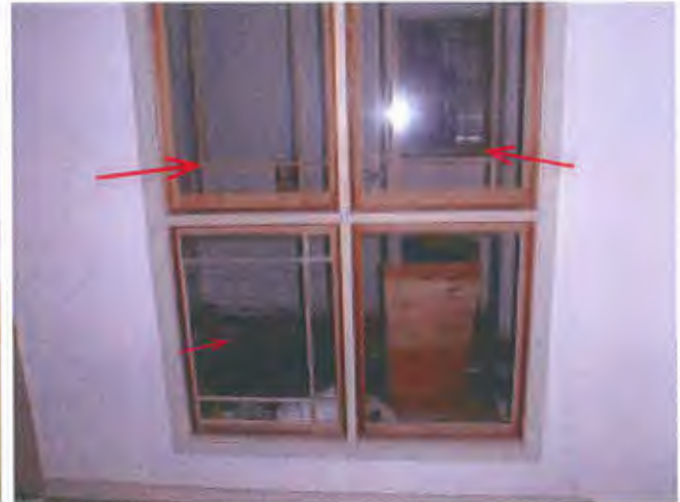
When you least expect it you find intact windows.

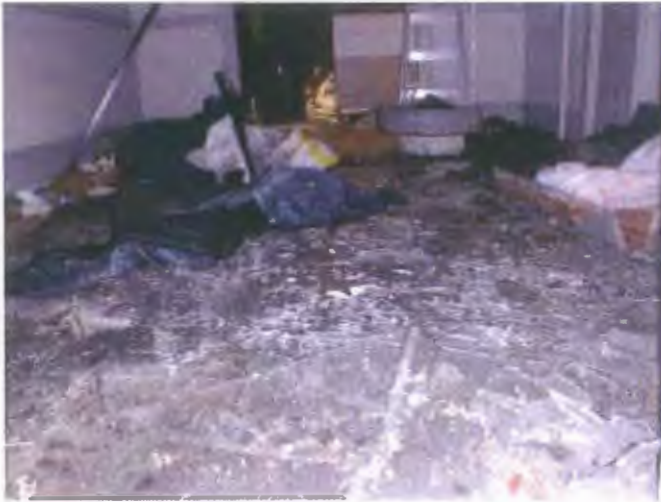
The building needs an amazing amount of clean up and repair.

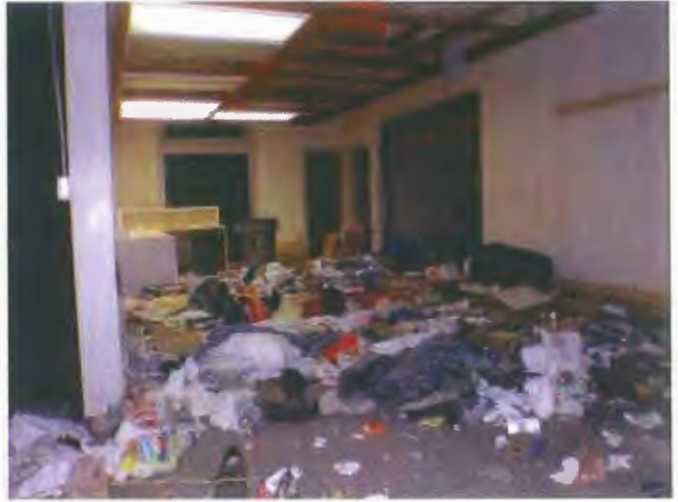
The upstairs needs considerable clean up and trash removal.

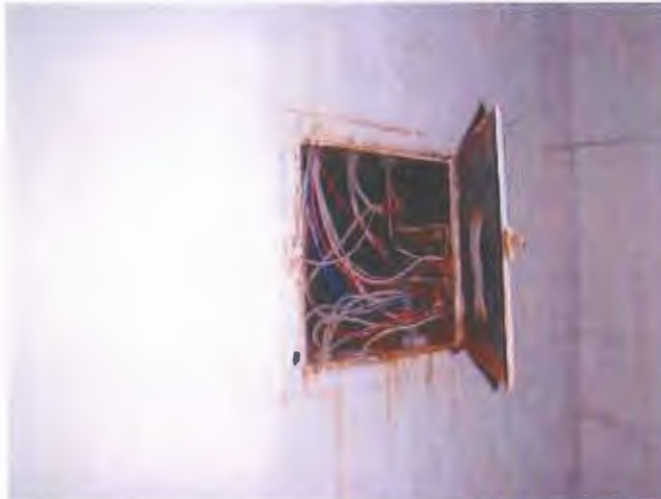
Rusting converted fuse panel now wiring splice panel. The roof leaks are destroying the building.

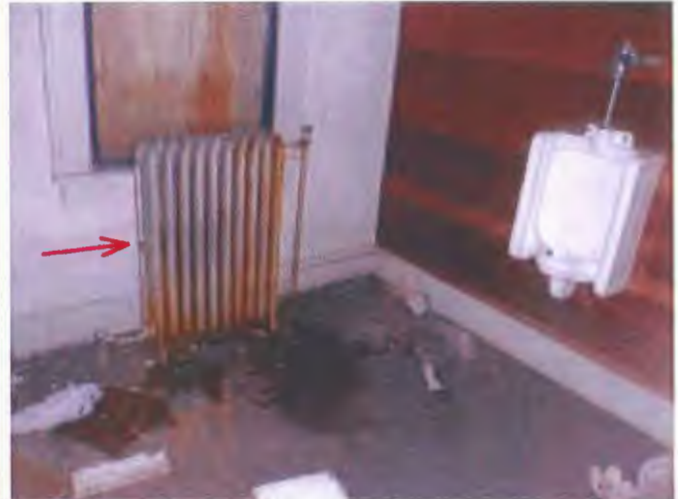
There are still some of the hot water heater radiators in the building.

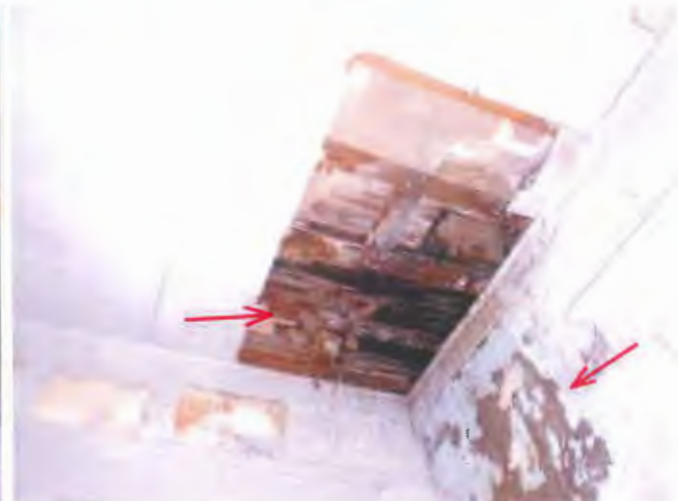
More roof leak ceiling and wall damage.

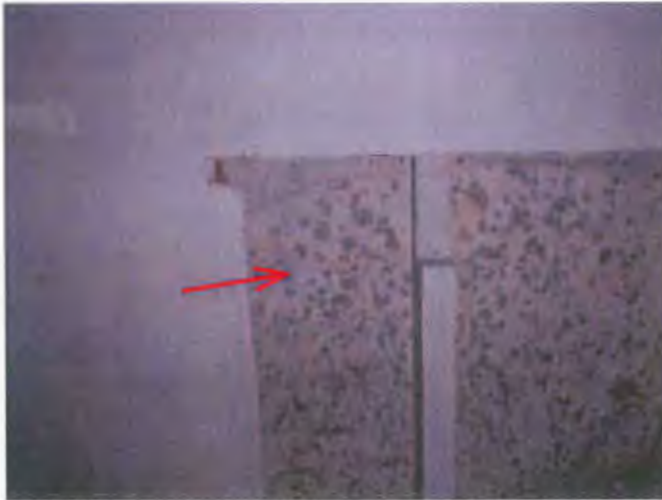
Mold developing all over but much worse on the south side. Roof needs immediate repair.

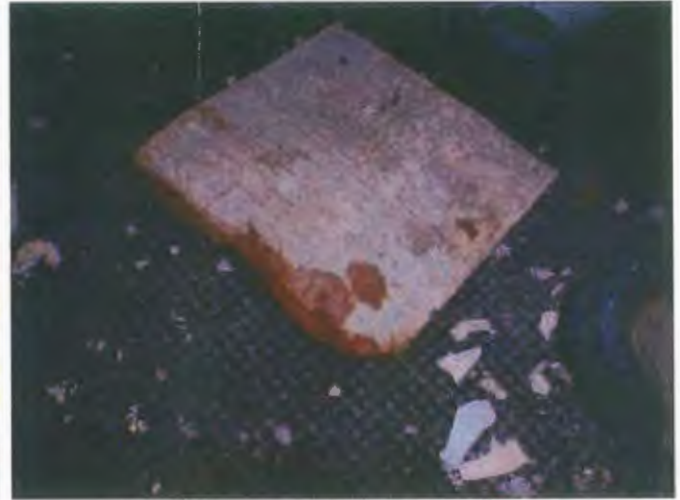
The ceiling tiles appear to be wood fiber but there appears to be an asbestos layer above them.

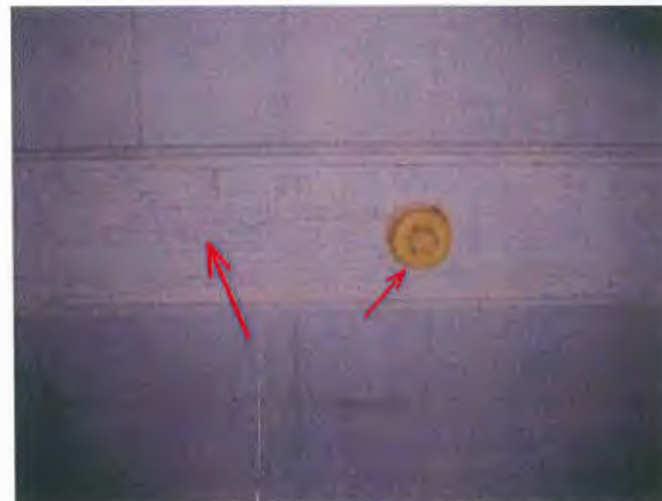
Lots of peeling lead paint and of course the old smoke alarms need replacement.

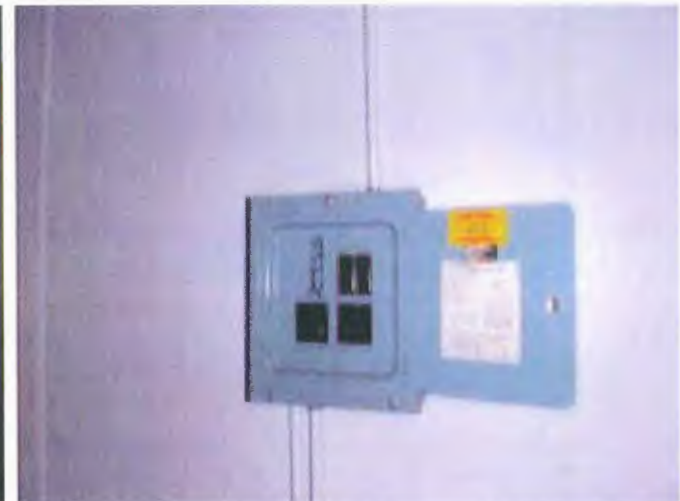
The building does have areas yet undamaged by the roof leaks and intact electrical sub-panels.

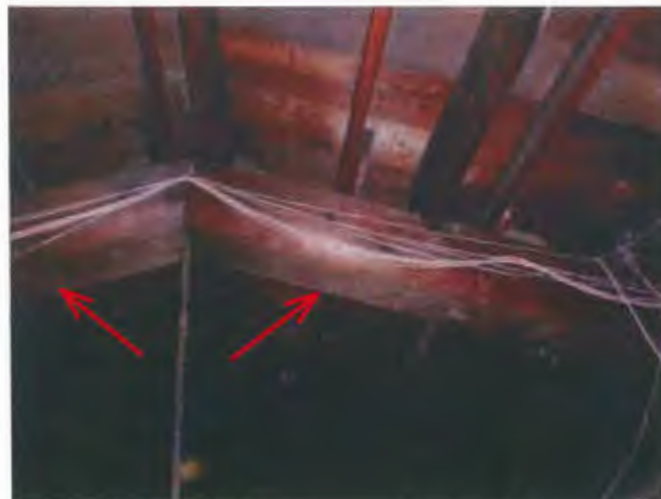
The timber roof trusses need the roof repaired immediately or you'll loose them.

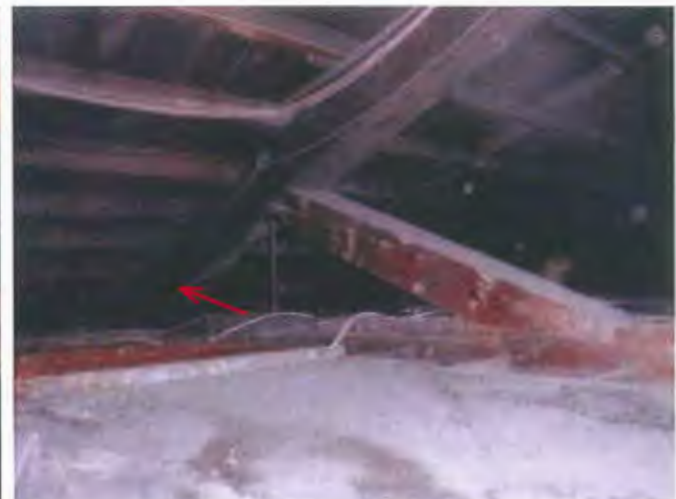
The ends of the heavy timber roof trusses are being wood rot damaged by the roof leaks.

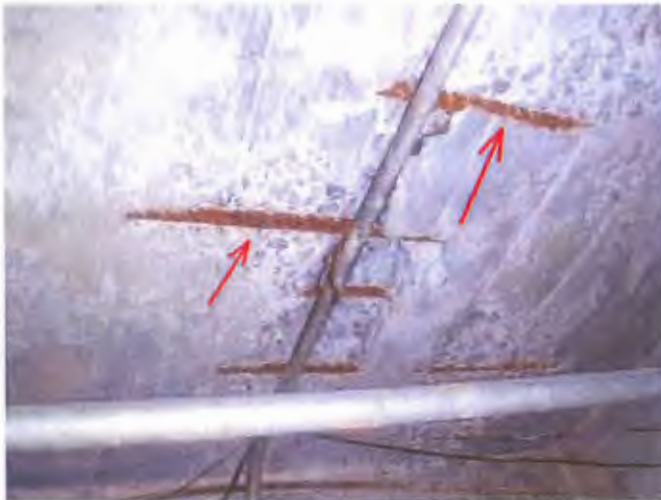
See the rusting exposed rebar in the basement ceiling below where the fire truck was parked.

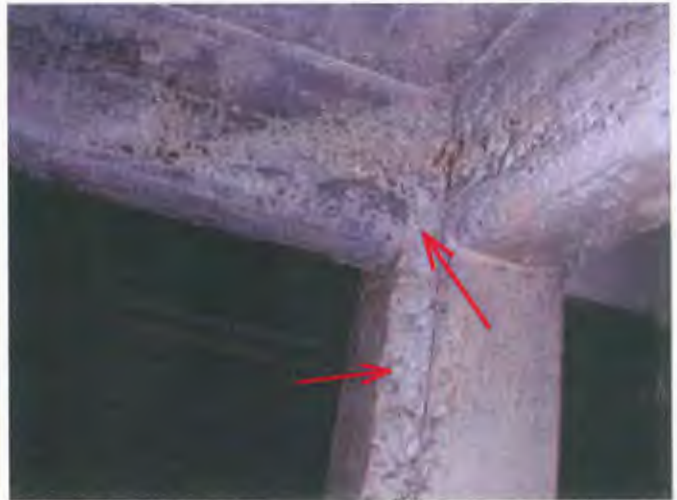
Rustic spawling basement column and floor beam concrete.

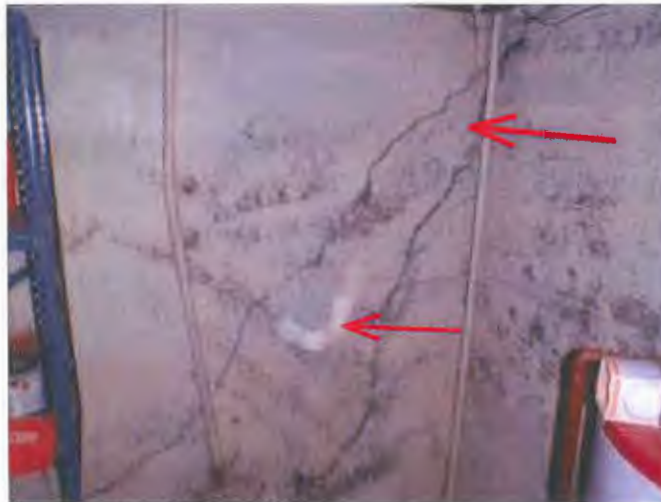
See basement SE area wall cracks.

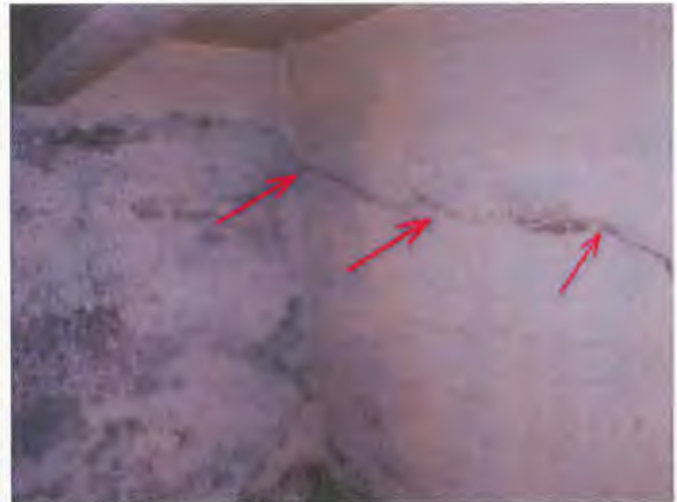
Some basement wall cracking appears to follow old concrete placement cold joints.

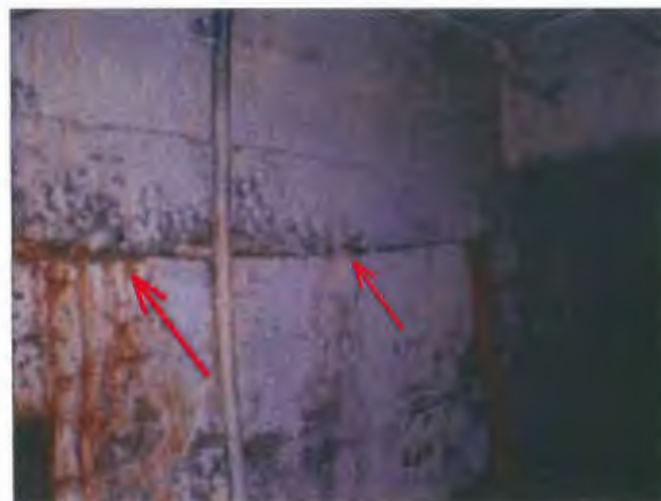
Water seeping in at the old basement concrete wall cold joints.
