Pre-Demolition Hazardous Building Materials Survey Report

USPS Processing & Distribution Facility
715 NW Hoyt Street
Portland, OR 97208

July 2018

Project No.: 25736.000 Task No.: 0001

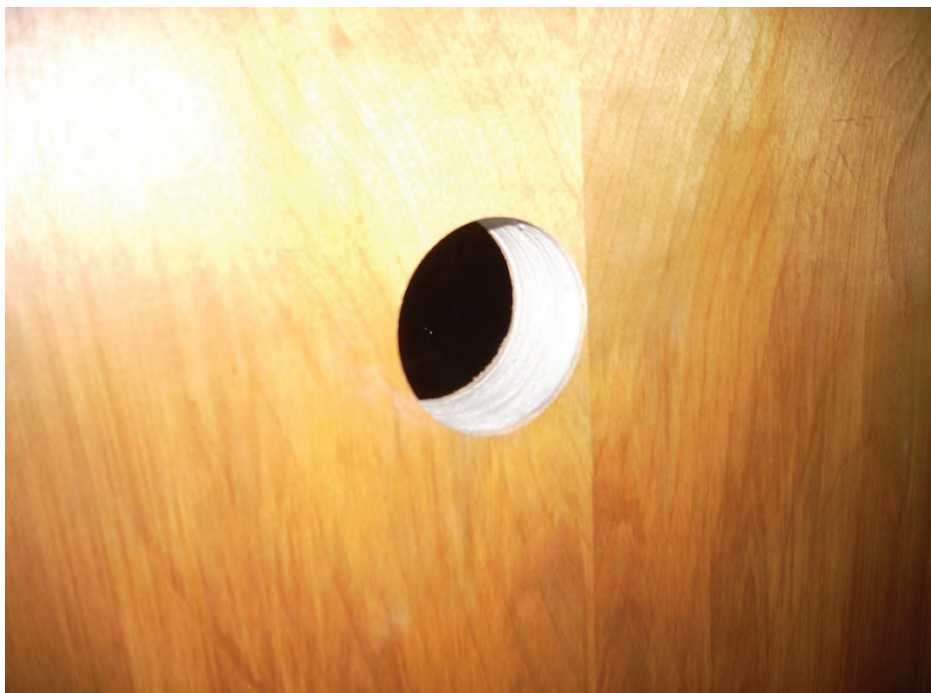
- One asbestos-containing fire door was discovered in the northwest corner of the tunnel system.
- Asbestos-containing insulating pipe wrap is present around a pipe penetration in the southwest stairwell.
- Asbestos-containing duct felt tape was observed in the southwest stairwell and southeast elevator control room.
- During a 1996 asbestos survey, cement asbestos board was discovered inside the southeast elevator control room. The cement asbestos board has since been removed.
- The stamp incineration room was inaccessible.

Photo 1. Fire door in tunnel system with exposed asbestos-containing core.

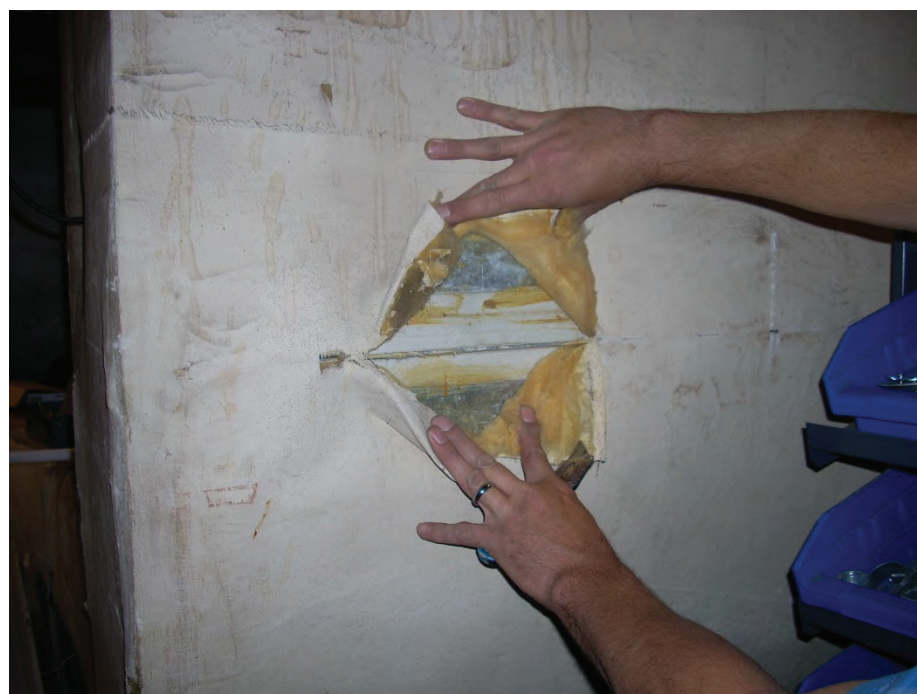
Photo 2. Asbestos-containing duct tape concealed under duct insulation.

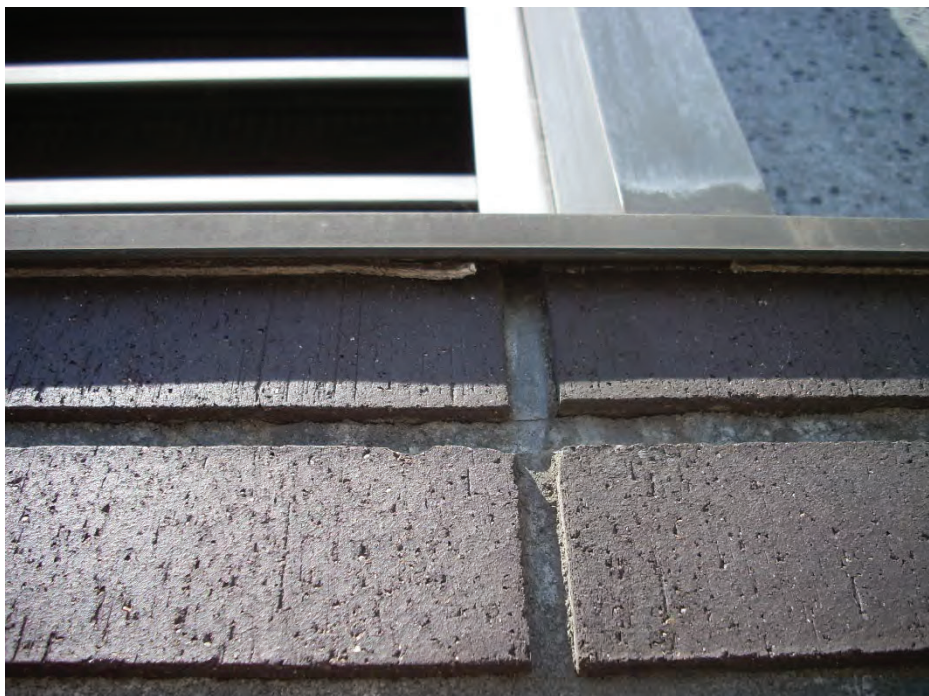
Photo 3. Asbestos-containing sealant between exterior flashing and brick.

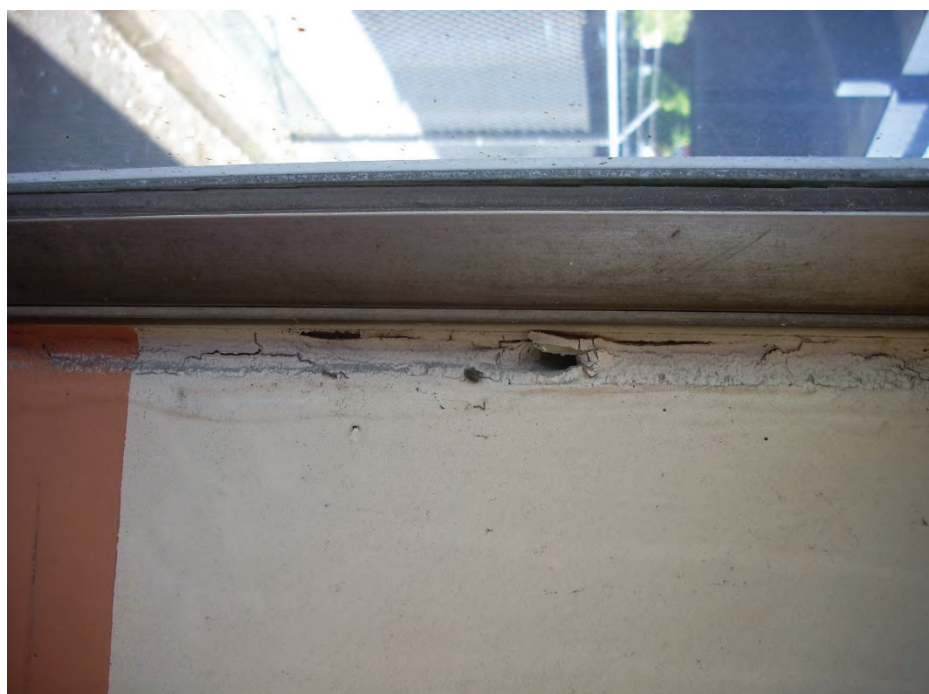
Photo 4. Vehicle maintenance shop window frame with asbestos-containing sealant between the frame and concrete.

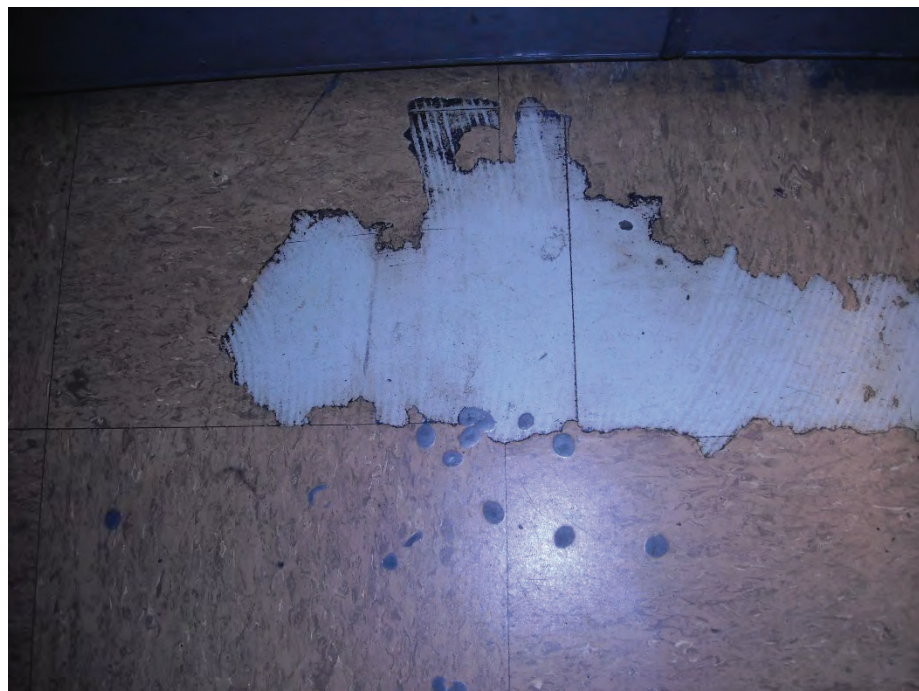
Photo 5. Vehicle maintenance shop office floor with two layers of asbestos-containing floor tile and mastic.

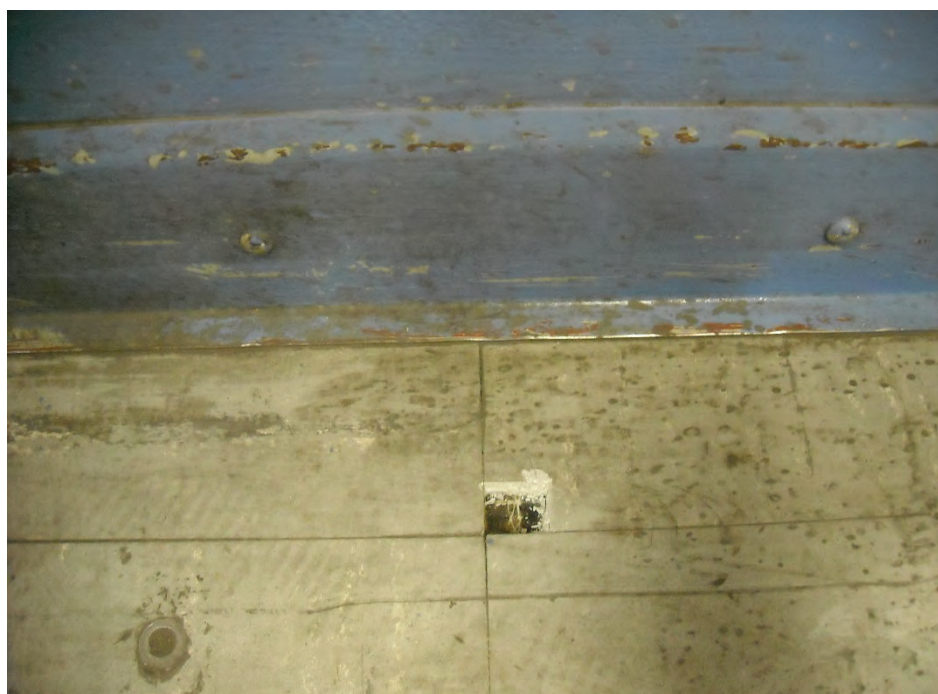
Photo 6. Room 129 asbestos-containing floor tile and mastic. Core sample location.

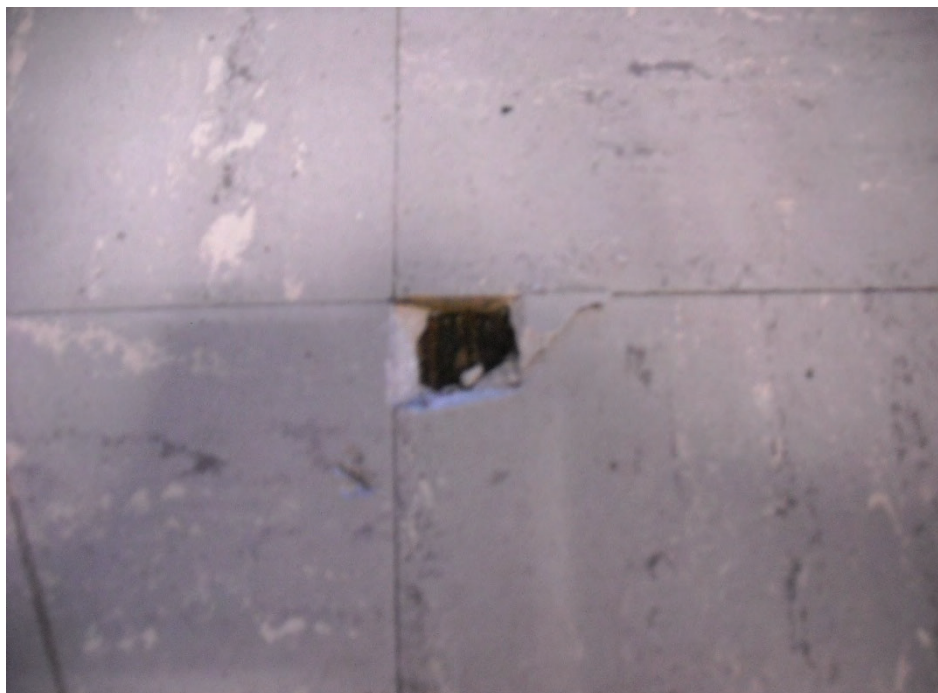
- Asbestos-containing floor tile and mastic was discovered exposed throughout the main workroom (room 3041) and office hallways. Asbestos floor tile and mastic was observed in the east elevator lobby (room 3000) during a 1996 asbestos survey. As of this 2008 survey the floor tile in the elevator lobby has been abated and replaced with ceramic tile.

Photo 7. Room 3041 asbestos-containing floor tile and mastic. Core sample location.

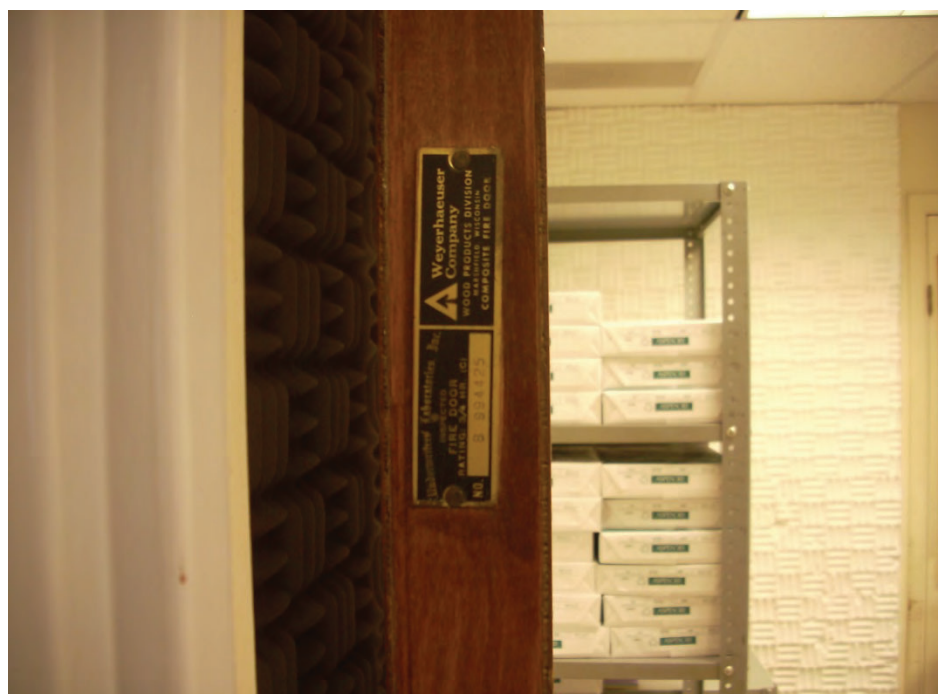
Photo 8. Labeling on a typical asbestos-containing fire.

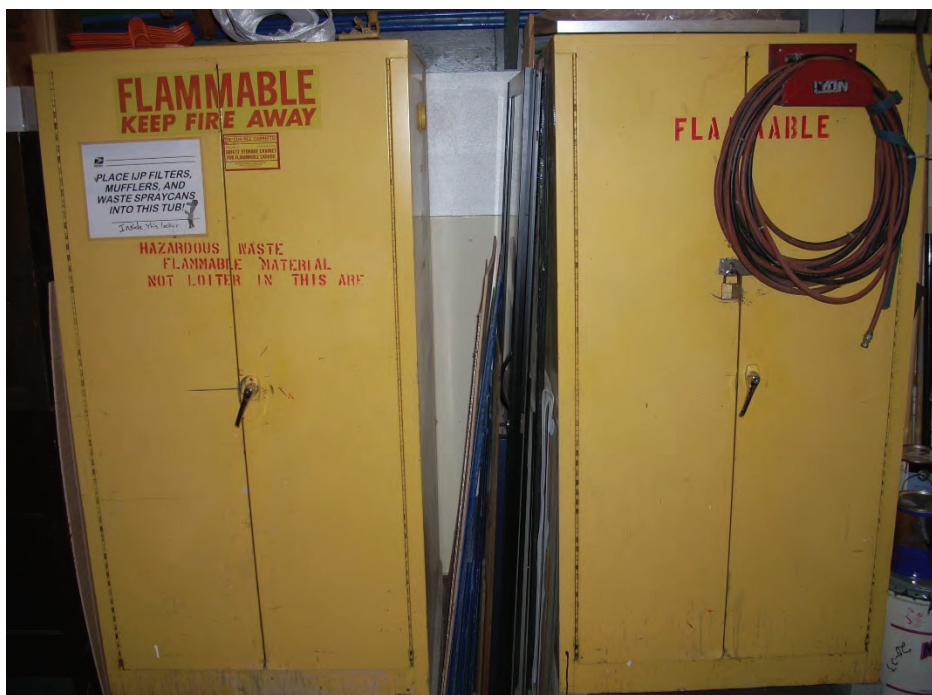
Photo 9. Hazardous materials storage in the boiler room.

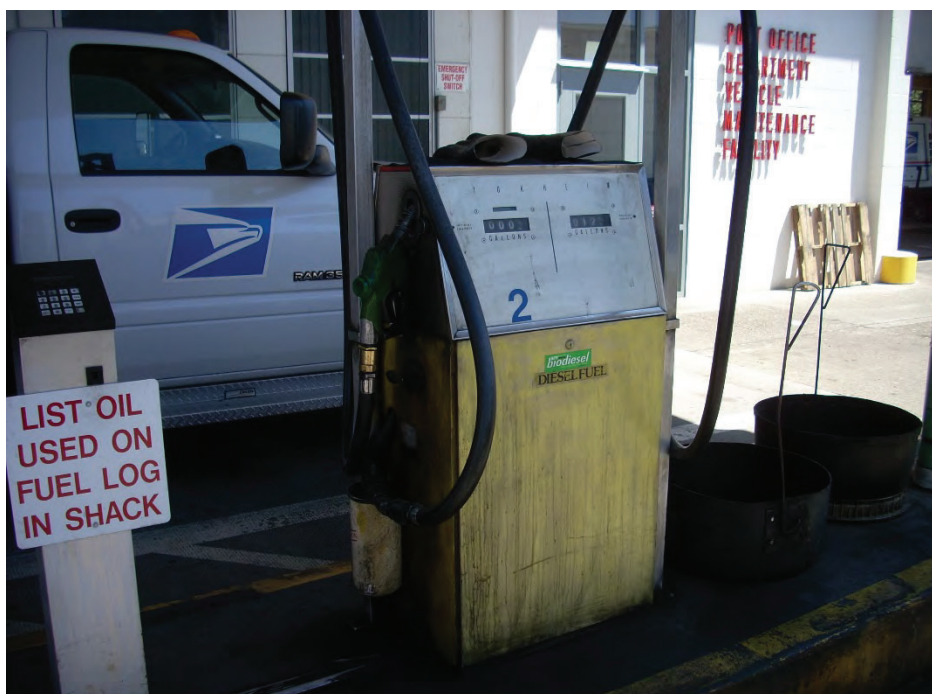
Photo 10. Fuel pumping station at the vehicle maintenance facility.
