Pre-Demolition Hazardous Building Materials Survey Report

USPS Processing & Distribution Facility
715 NW Hoyt Street
Portland, OR 97208

July 2018

Project No.: 25736.000 Task No.: 0001

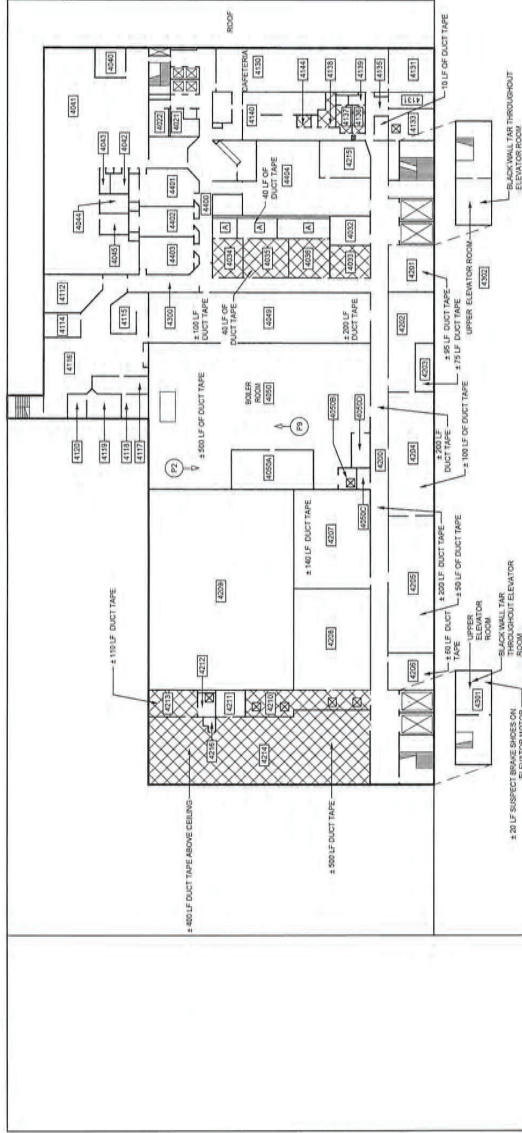
FOURTH FLOOR PLAN

| CHANGING REFERENCE | FIELD CODE | LAB RESULT | NOTED/AL SAMPLED |
|---|---|---|---|
| 21193.000-023 | 21193.000-023 | (+/-) | VINYL FLOOR TILE CORE |
